## ERRATA

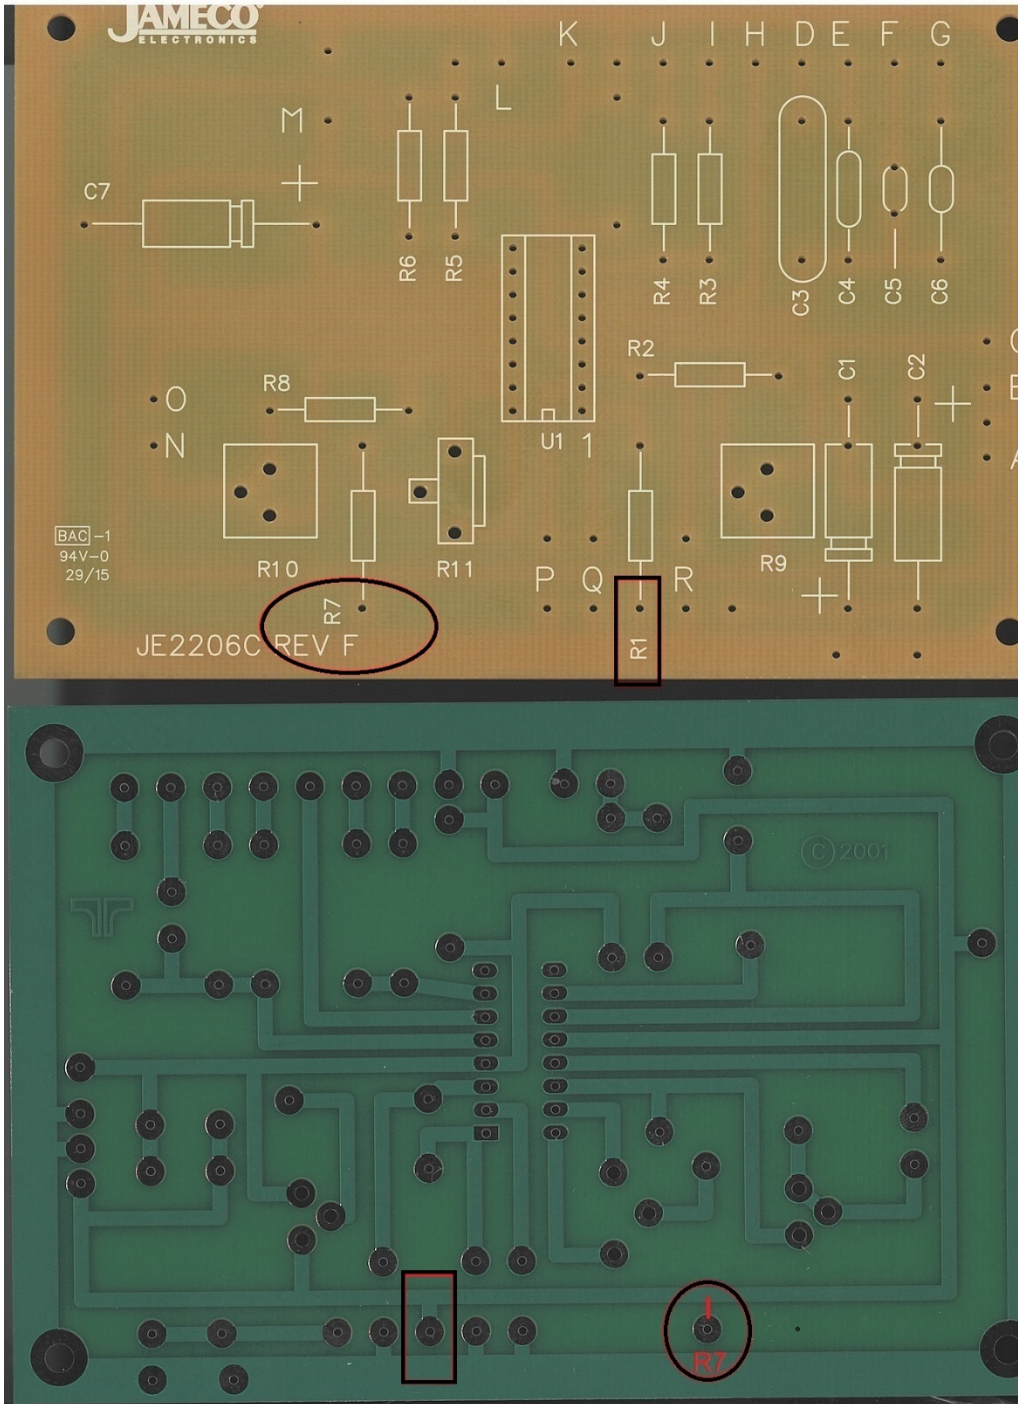
For PCBs marked with JE2206C REV F, the bottom-most pad of R7 (circled below) did not get connected to the trace during PCB manufacturing. It can be fixed by installing a jumper from the unconnected pad of R7 to the pad of R1 nearest the edge of the board (boxed area below).
